**Project: Skyline Water District, 5000 Gal. Hydro
Pneumatic Tank Inspection CMT –
Nelson Engineering**

SUMMARY INSPECTION REPORT

Subject: Pressurized Water Tank, E210470n Skyline Water District, Jackson Hole, WY

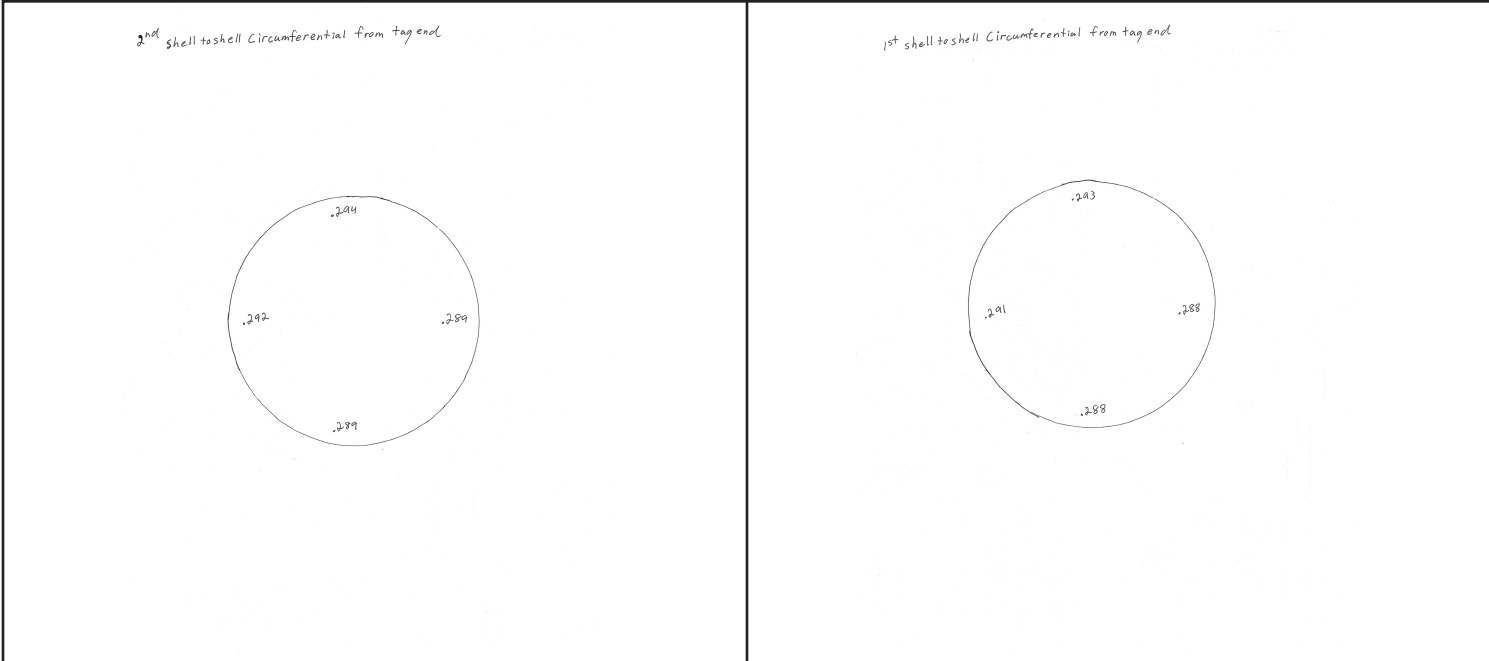
2nd shell to shell circumferential weld from tag end. Measurements approx. 2-3" from weld

1st shell to shell circumferential weld from tag end. Measurements approx. 2-3" from weld
